Duthie Park: A Cycling Audit

Produced by Aberdeen Cycle Forum

August 2020

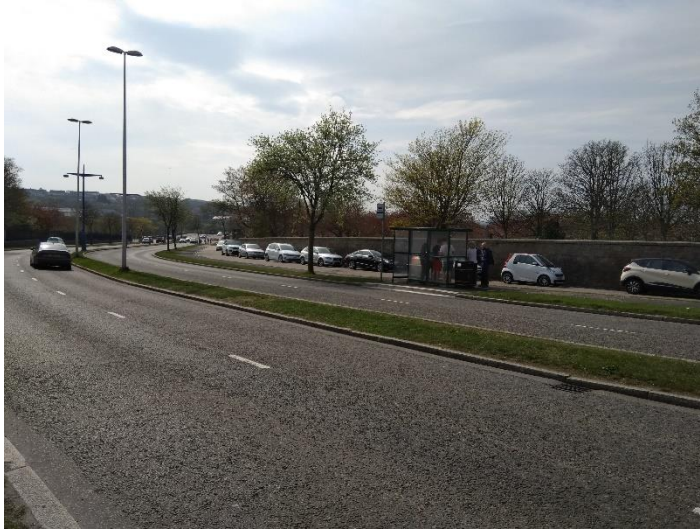
- v) Gateway, west. This gateway opens onto Great Southern Road. This is most likely point of arrival for those arriving by public transport, with a bus stop close by (other bus routes are available e.g using Polmuir Rd/Murray Terrace). The stop on the south-bound carriageway is convenient, however accessing the stop on the north-bound carriageway opposite means crossing a dual-carriageway without any controlled crossing. The central reservation is narrow and does not provide a safe refuge, and has no dropped kerb to accommodate for example wheelchairs or push-chairs. For cyclists, this gateway is of limited use as the pavement here is not designated as a shared-use and therefore should not be used by cyclists, although anecdotally it is used by some in preference to cycling on the busy dual-carriageway.

Figure 2: lack of safe crossing for pedestrians to the north-bound bus stop. Pedestrians wishing to access the bus stop on the north-bound carriageway without making a potentially hazardous crossing would be better to exit via the south-west gateway and make use of the Toucan crossing nearby, although this may be indirect and counter-intuitive.

- v) A safe and controlled (e.g. Toucan) crossing over Riverside Drive west of George VI Bridge**
- vi) A controlled crossing or at least a central refuge for pedestrians on Great Southern Road opposite the park's West entrance.**

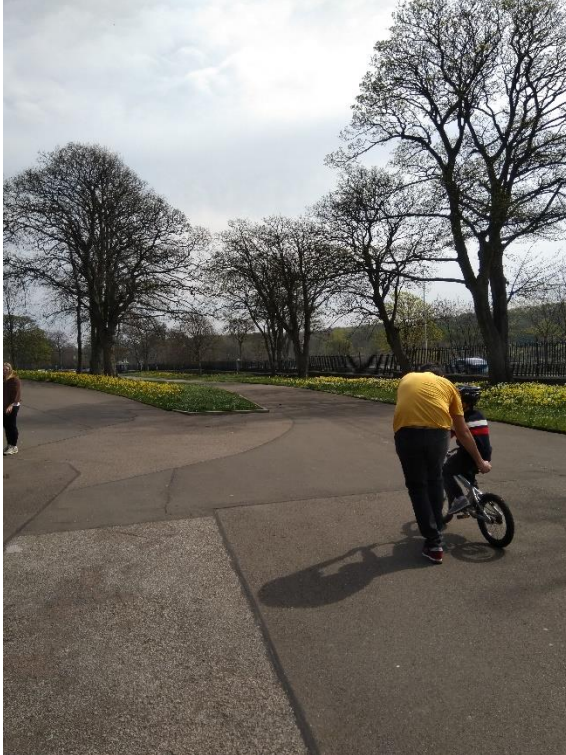
7. The cycling environment within the park itself is generally very good. The majority of paths are several metres wide, are well surfaced and either flat or with gentle gradients. The width of the paths means that even when the park is busy, there is ample room for everyone and we are not aware of conflicts between pedestrians and cyclists. There is no delineation of a cycle route nor is any priority indicated where paths form junctions. We would not expect that these are justified and generally cyclists and pedestrians appear to mix well, although occasional conflicts cannot be totally ruled out. The greatest potential for conflict is likely to be in the busiest areas, particularly in front of the café and winter gardens, or close to the main gates where movements are concentrated. The congestion and potential for cycle/pedestrian conflict in front of the winter gardens at busy times is not helped by the location of numerous large ornamental stones, which may also present an additional hazard in the dark.

Figure 3: wide, well surfaced paths make attractive places to cycle especially for families

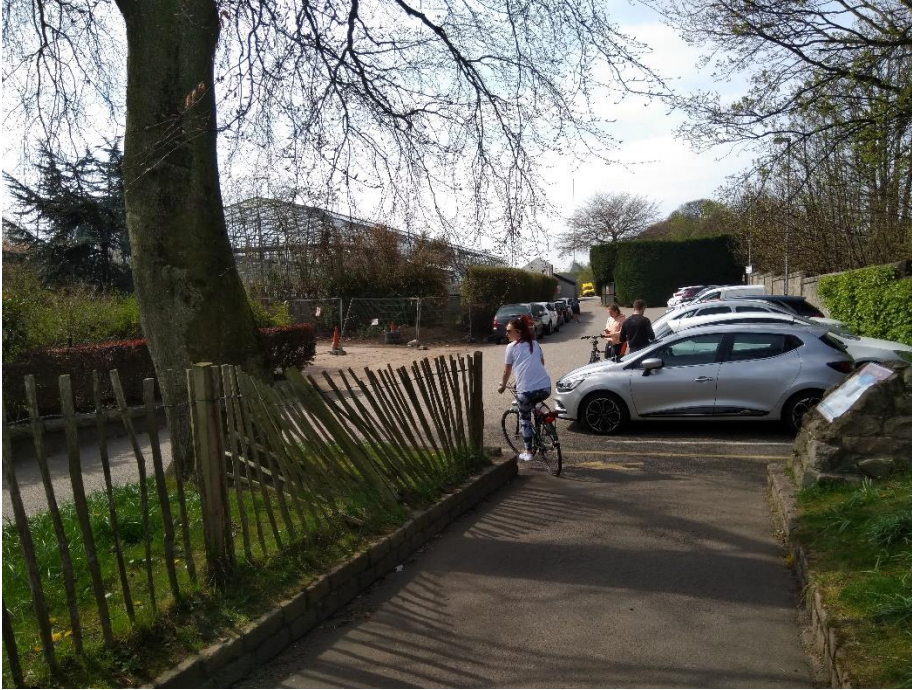
9. The layout of the ramp onto the Deeside Way from the car park, and access to and from the main gate is poor. The ramp itself involves negotiating two 90 degree bends, with a further two bends at the foot of the ramp in the car park itself (Fig 4). Although most experienced cyclists will tackle these bends relatively easily, less confident cyclists may not, and the bends exacerbate the potential for conflict with pedestrians. At the foot of the ramp, where the route joins the car park, the marked parking bays leave a gap of just over 2 metres between where a car may be positioned and a low stone wall. This is a very poor layout which invites conflict between pedestrians, cyclists and motor vehicles.

Figure 4: foot of ramp connection with the Deeside Way

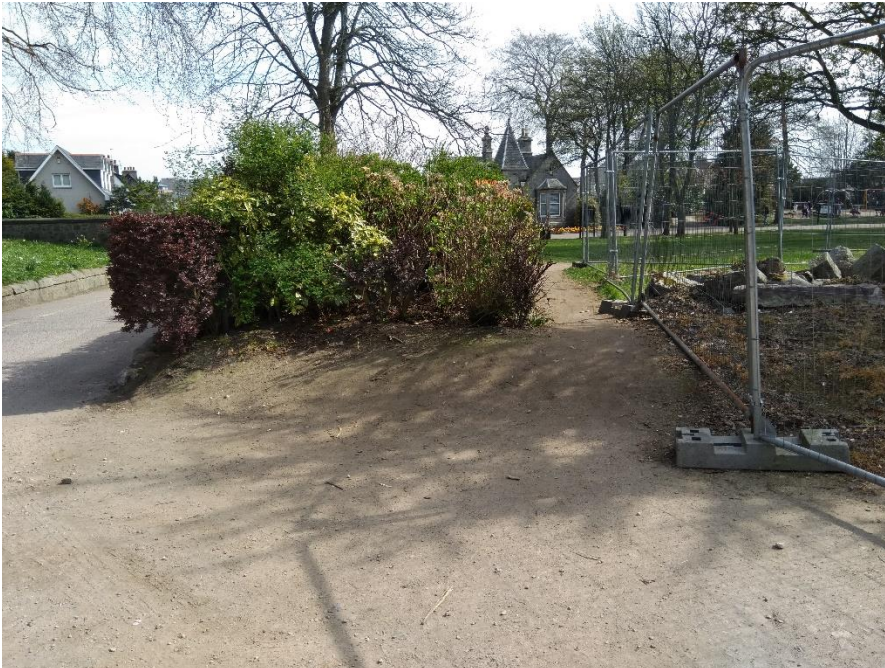
A further oddity in the layout of access from the north gate and car park is the creation of an apparently temporary vehicular entry point, immediately east of the Winter Gardens (Fig 13). The purpose of this is unclear. It has not been properly surfaced for vehicle use which may indicate it is intended to be temporary, but on the other hand it has now been present for a number of years. Use of Heras (i.e. temporary security) fence is intended to prevent pedestrian access here, but there is an obvious desire line and casual observation of visitor behaviour shows that they are bypassing the Heras fence rather than using the main north entrance point. The vehicular entry point here also now appears to be routinely used for parking by members of the public. This represents a loss of amenity to the park itself, is untidy and also defeats the apparent wish to limit the availability of parking in order to encourage use of public transport and active travel. As the entrance to this unofficial parking or access area is more or less directly opposite the access ramp from the Deeside Way, the additional vehicle movements are likely to exacerbate the potential for pedestrian/cycle/vehicle conflicts at this point. We understand that the intention is to form this temporary access into a service road for the café in due course.

Figure 5: desire line bypasses the Heras fence, perfect location for a new formalised pedestrian and cycle path?

There is an obvious opportunity here to formalise a pedestrian and cycle entrance from the car park to the park at this location thus reducing the number of people being forced through the bottle-neck.

- iii) The temporary or informal access/ parking off the north inner car park is something of an aberration which defaces the park. However, this would be an ideal location to provide a pedestrian and cycle path giving direct access to the park, to avoid visitors arriving via the Deeside Way from having to transit through the bottle-neck and outer car park to use the main gate.**
- iv) A contra-flow for cyclists wishing to exit the park via what is currently the south-east entrance point should be provided.**

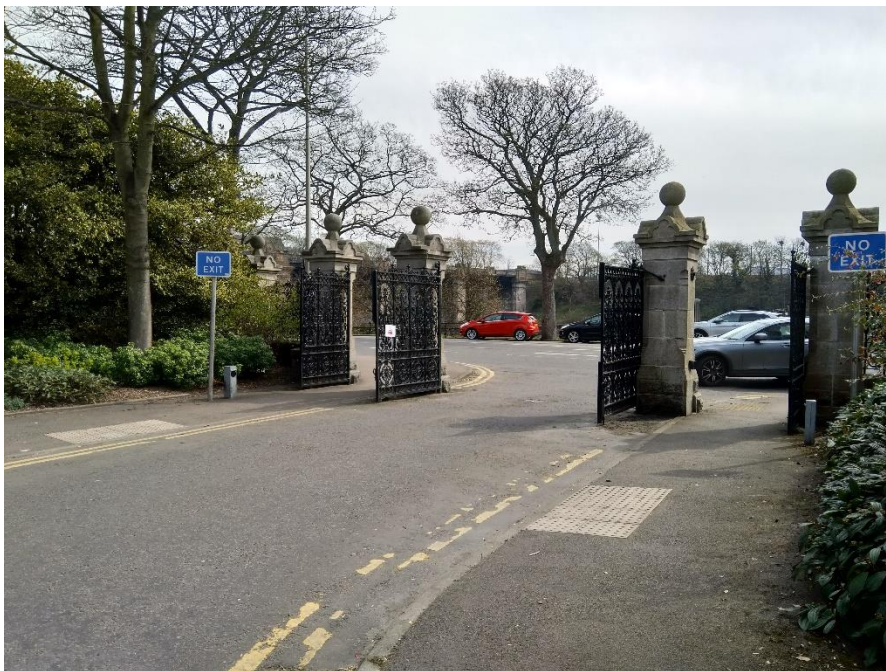
- ii) Main entrance, south, from Riverside Drive (Fig 6) This is a one-way entrance point for vehicular traffic, with a side gate accessible by pedestrians. The layout is confusing for cyclists and unclear if they are expected to behave as 'pedestrians' or 'vehicles'.

For cyclists travelling east, the obvious exit point is at the south *entrance* where the current one-way layout for traffic is unhelpful to say the least. Cyclists travelling from the Riverside SUP towards the park can use a Toucan crossing (although confusingly also labelled with 'Cyclists Dismount' signage) but then have to negotiate a confusing and unhelpful layout around the gateway. Pedestrians are apparently expected to cross the flow of traffic either outside, or just inside the gate at a point where a driver's vision may well be obstructed by the large stone pillars. Cyclists are possibly expected to either re-join the traffic, or behave as pedestrians and push their bikes on the pavement which skirts the car park to access the Park itself (the pavement being narrower than the accepted norm for a shared use facility). The suitability of this layout for children or families is very dubious. Cyclists wanting to use this gateway to *exit* the park would currently be required to dismount and walk along the pavement. However given the inconvenience of doing so, it is likely many will risk cycling against the flow of traffic.

Figure 6: south vehicular *entrance* is not well designed for cyclists, or pedestrians (pavement on right side of image ceases at this point, so pedestrians then mix with traffic, or must cross to pavement on left side of image)

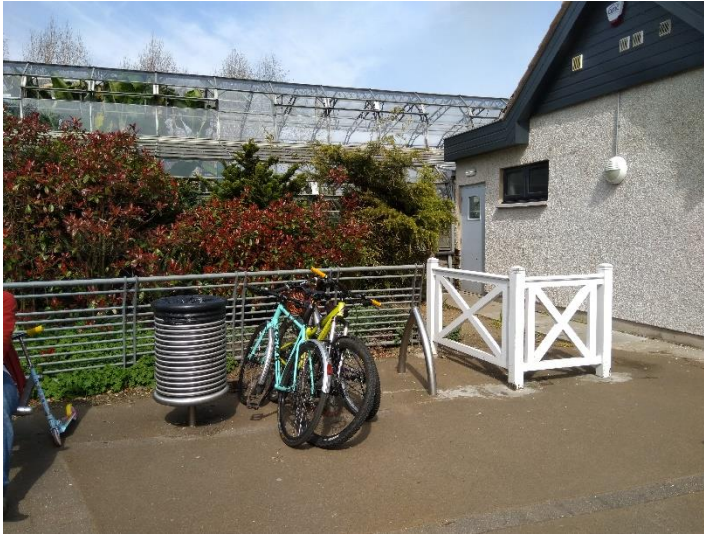
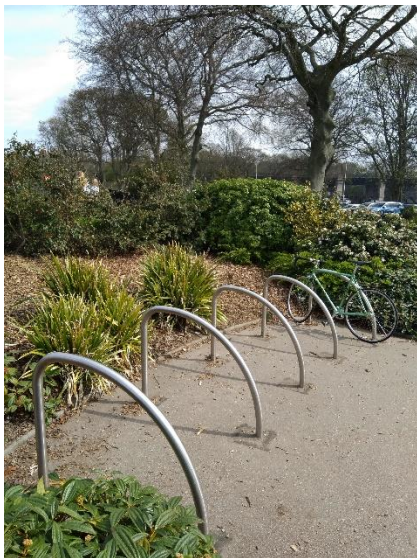
11. Opportunities for formal cycle parking within the Park are limited to just two locations. Two 'Sheffield' bike-stands (i.e. max capacity 4 bikes) outside the café, near the Winter

Gardens, and five (max capacity 10 bikes) beside the larger play area, close to the south car parking area¹.

Figure 7a, 7b: parking for only 4 bikes at the Winter Gardens & café, up to 10 bikes at the south play area.

- i) **New cycle parking facilities should be provided. We would suggest parking capacity of at least 20 be created close to the Winter Gardens and café. There is also obvious demand for bike parking at the north play park area, and parking could also be beneficial at other points dispersed throughout the park. Design guidance is available within 'Cycling by Design':**
https://www.transport.gov.scot/media/14173/cycling_by_design_2010_rev_1_june_2011.pdf
- ii) **The layout of the north car park and gateway is currently poor and could be improved to provide more priority for pedestrians over vehicles, and clearer indication of how cyclists are expected to behave.**

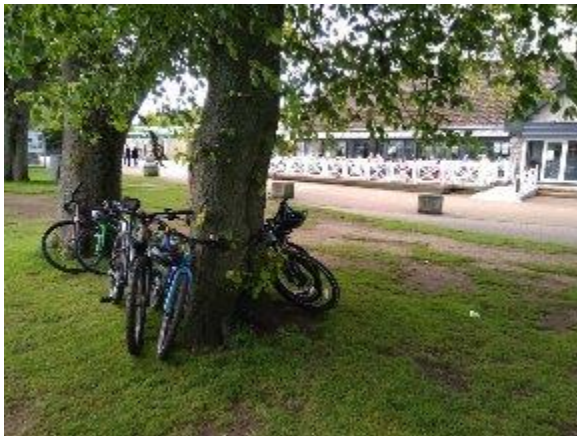
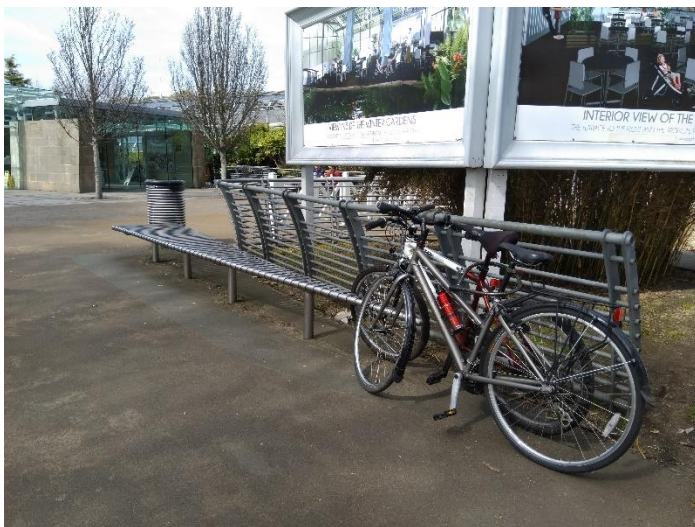
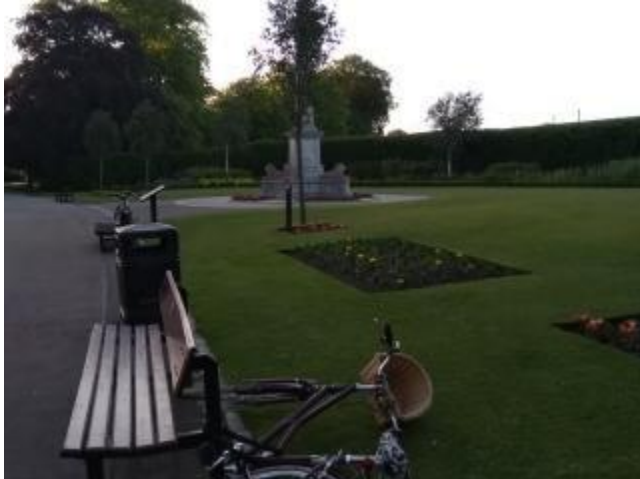
For a park which has so much potential appeal for visitors by bike, the amount of cycling parking provided is clearly inadequate. This is evident on almost any visit to the park when cycles will be seen leaning against trees, bins, railings, or benches. This is inconvenient for the cyclist, with a risk of damage both to the bike and the object in question, and an increased risk of theft if the bike cannot be secured properly. At busy times during summer months, it is not unusual to see 10 – 15 bikes at any one time improperly 'parked' in the vicinity of the winter gardens.

Figure 8a, 8b, 8c: bikes left where there is no proper parking provision can cause an obstruction, are easily damaged and may not be secure against theft.

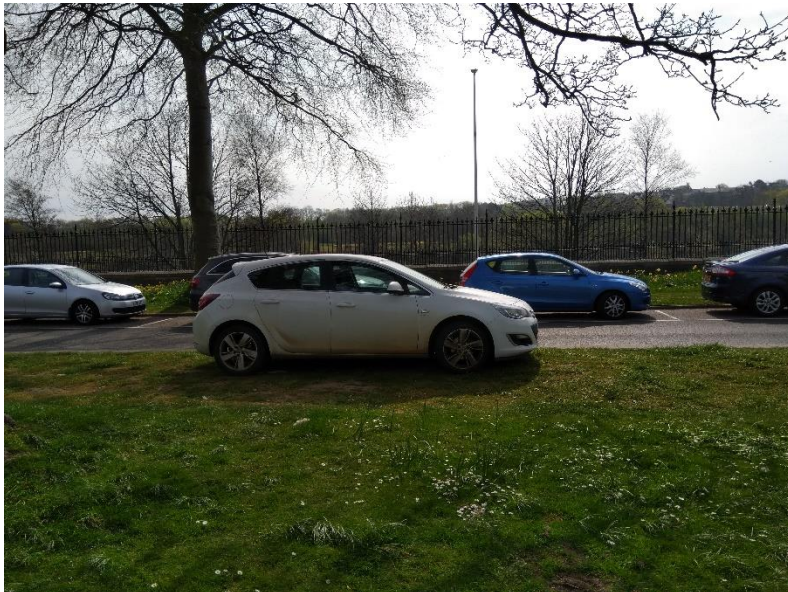
Figure 10: Excess demand leads to unauthorised parking on the grass

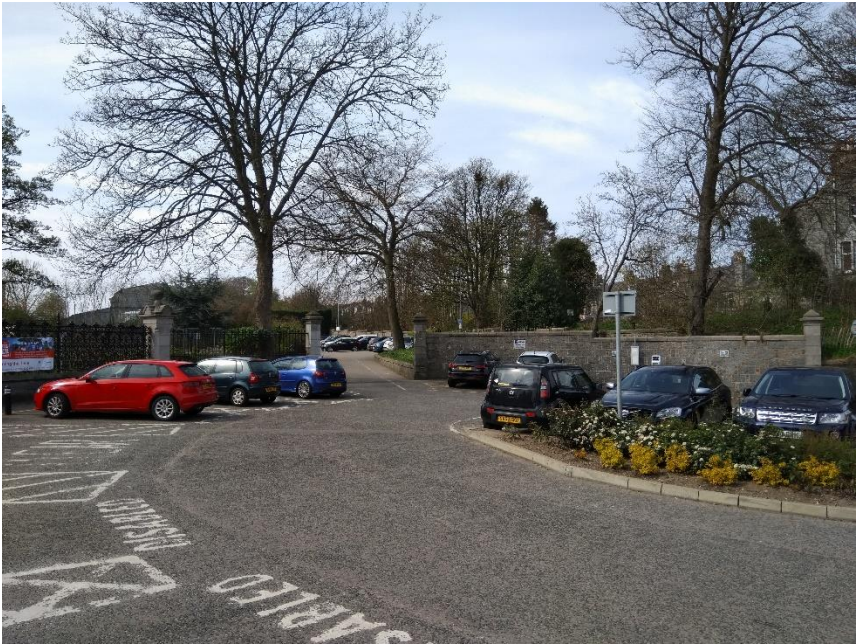
Having exited the Deeside Way en route to the park a cyclist must now pass through a narrow bottle-neck (Fig 12) between the inner and outer car parking areas. There is no pavement at this point although a yellow line (now quite worn) has been painted indicating where pedestrians are expected to walk. There is no specific provision for cyclists, and as with the south entrance, cyclists may be unclear as to whether they are supposed to behave as pedestrians or vehicles. Although confident adult cyclists may be comfortable joining the flow of traffic, it must also be remembered that many of the users of the Deeside Way are families with children. The current layout and expectation that cyclists here have to mix with traffic here is far from ideal.

As parking capacity is limited, and time restricted, this leads to a greater number of vehicle movements through the bottle-neck than would otherwise be the case. At busy times, vehicles can be observed entering the inner car park in the hope of finding a space only to find it full and then having to leave again immediately. Excess demand for parking also leads to cars being parked outwith marked spaces which may adversely affect visibility and create additional hazards. Cars have even been seen occasionally parking on the yellow-painted strip intended for pedestrians, thus making the bottle-neck significantly worse.

Figure 12: North car park (outer) and showing bottle-neck to inner car park (centre of image)

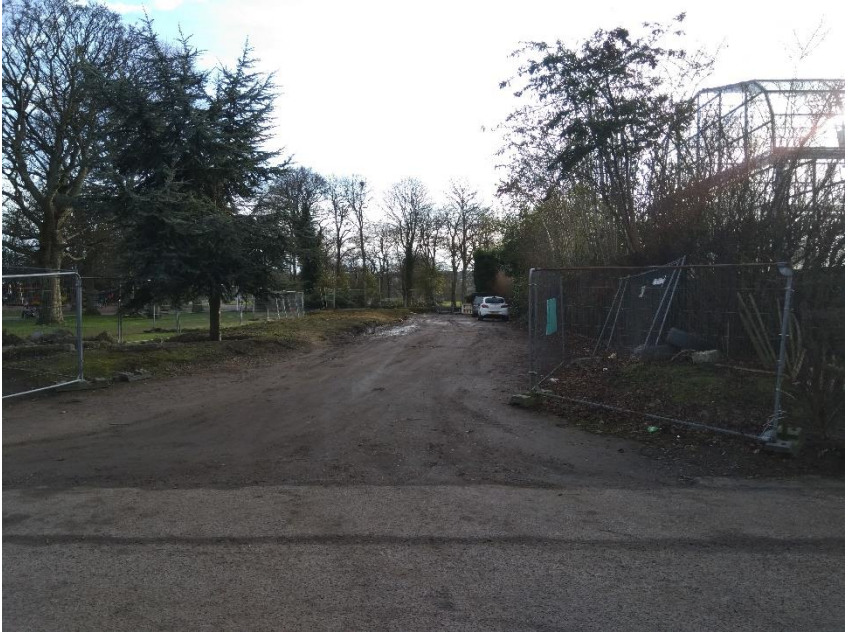
Figure 13: Temporary (?) access road east of Winter Gardens
