Duthie Park: A Cycling Audit

Produced by Aberdeen Cycle Forum

August 2020

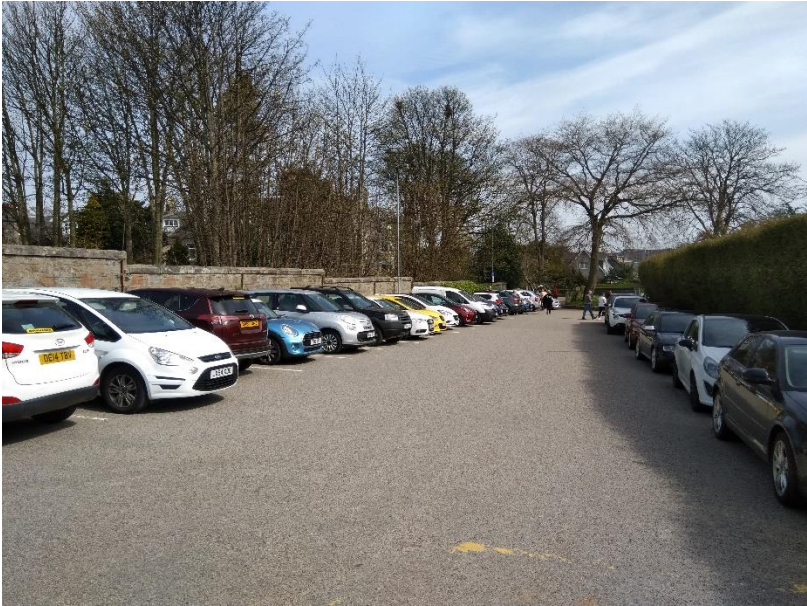
Figure 11: North car park (inner)

As parking capacity is limited, and time restricted, this leads to a greater number of vehicle movements through the bottle-neck than would otherwise be the case. At busy times, vehicles can be observed entering the inner car park in the hope of finding a space only to find it full and then having to leave again immediately. Excess demand for parking also leads to cars being parked outwith marked spaces which may adversely affect visibility and create additional hazards. Cars have even been seen occasionally parking on the yellow-painted strip intended for pedestrians, thus making the bottle-neck significantly worse.
